JACKPILE-PAGUATE URANIUM MINE RECORD OF DECISION COMPLIANCE ASSESSMENT

September 2007

Prepared for:
Pueblo of Laguna

Prepared by:
OA Systems Corporation

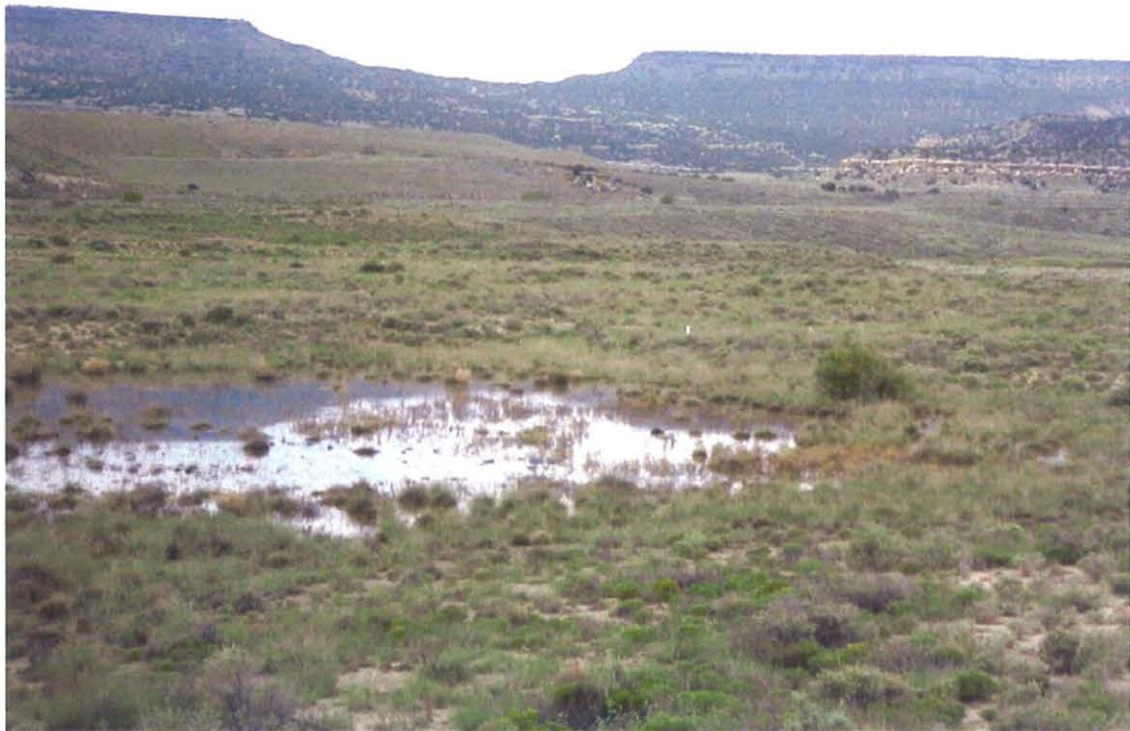
Discussion - From the OAS site inspection, there is a permanent pond/wetland area in the North Paguate pit. A photograph of this ponded area is found in Appendix B, Photo B-1. This photo contains the NP-OP-20W well shown near the ponded area. The water table elevation of that well is not compliant with the ROD. The ponding is also evidenced by aerial photos (Appendix E) and established wetland vegetation species. Although, the Jacobs Environmental Monitoring Plan required that all ponded water within the pits be monitored annually for chemical constituents, there was no water quality data for this ponded area. A sample was collected from the NP Pond in 2007 which indicates elevated concentrations of radiologicals. These results are discussed in Section 10-Monitoring. Additional sampling and assessment of this situation will be needed to draw conclusions on the risk to humans, wildlife or domestic stock.

Photo B-1: Permanent Pond in NP-OP-20 near MW 20 W

- During preparation of this report, OAS made the recommendation that the two wells required by the ROD should be installed in the Jackpile Pit. This was done in April 2007
- Water table elevations should be monitored over a number of years to determine if the levels have stabilized, or are increasing or declining in order to evaluate whether the 10-foot below surface requirement is being met.
- Ponded water, wherever found within the pits, should be collected for chemical and radiological analysis.

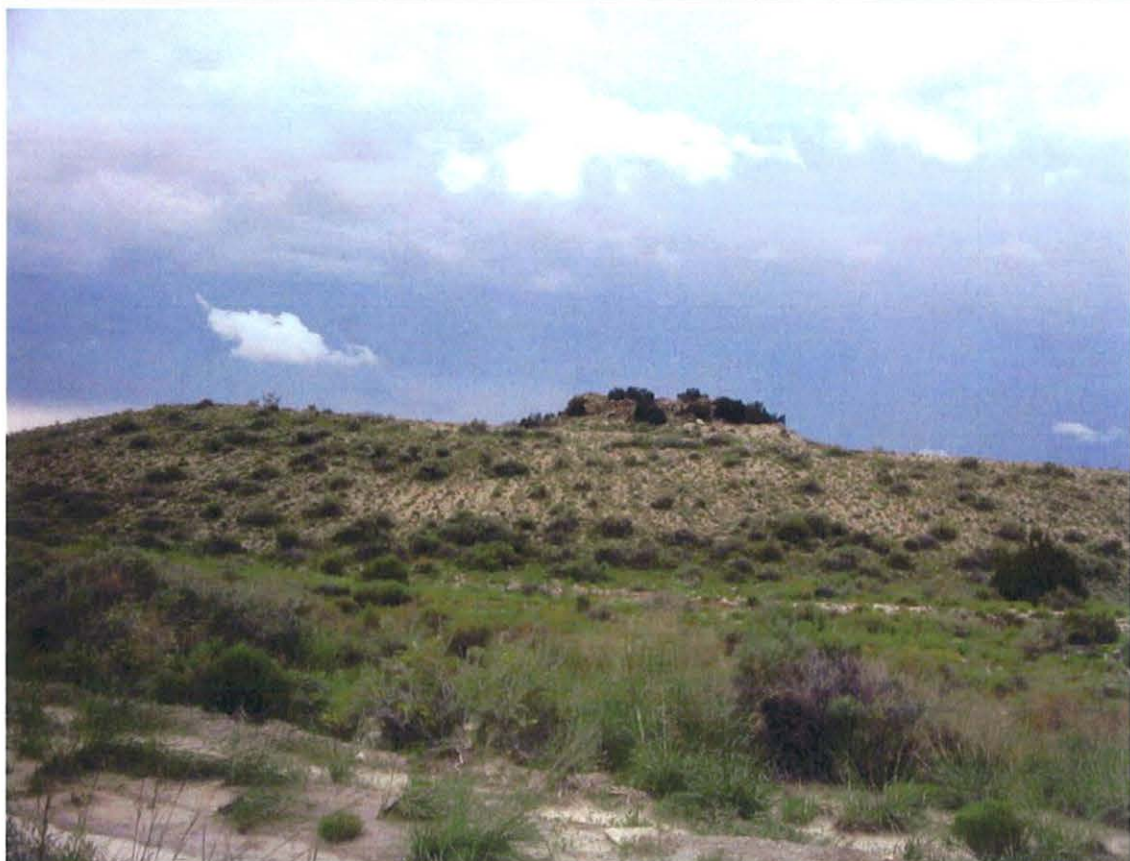
Photo B-2: North Side of Waste Pile "H"

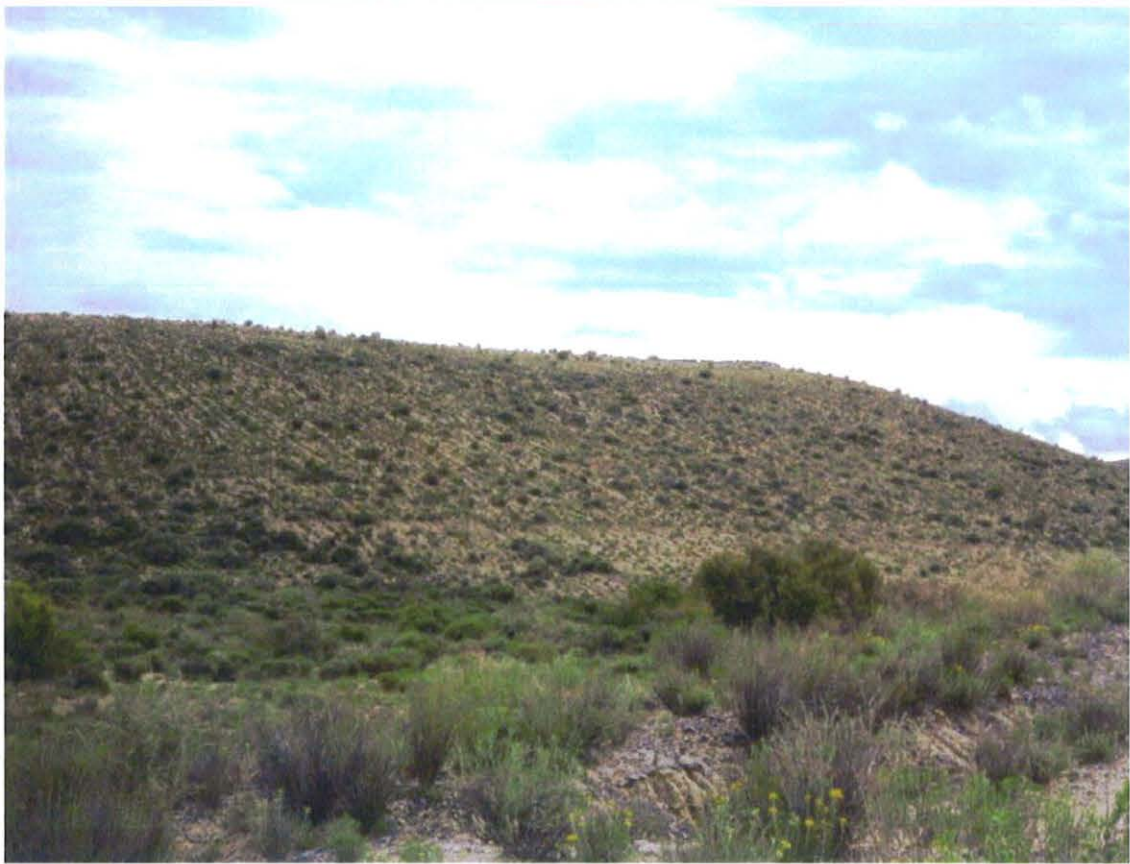
Waste dump J was found to not be blocking the stream. Distance made it uneconomical to transport the waste into the Jackpile pit, therefore, it was not removed. It was sloped, covered and seeded.

Photo B-3: Waste Pile "J" - Sloped and Seeded

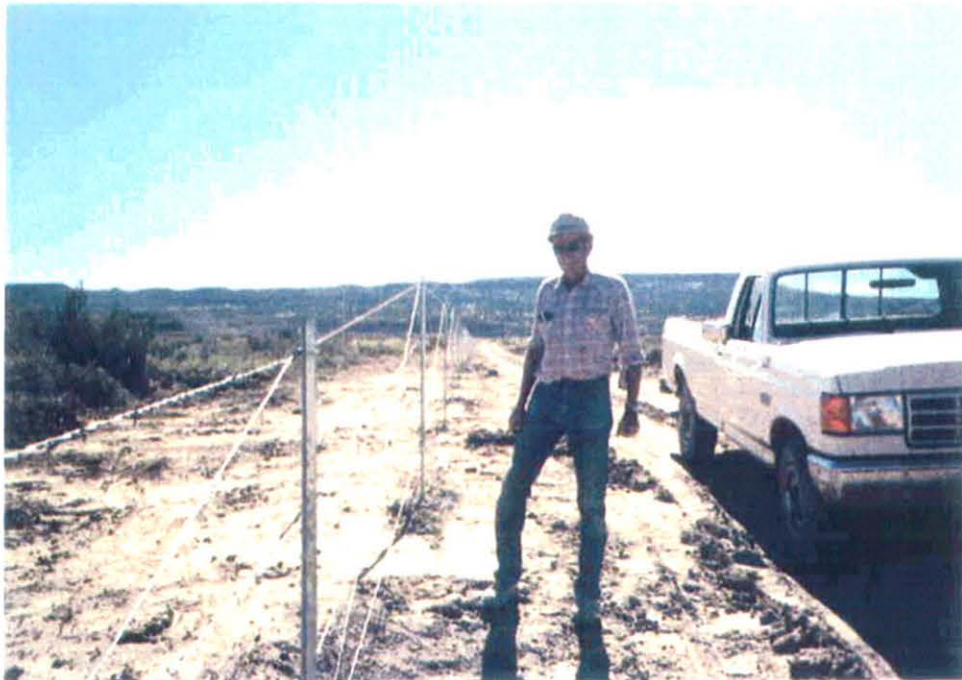
Photo B-4: Fencing Photo from Monthly Report No. 14, Figure 3

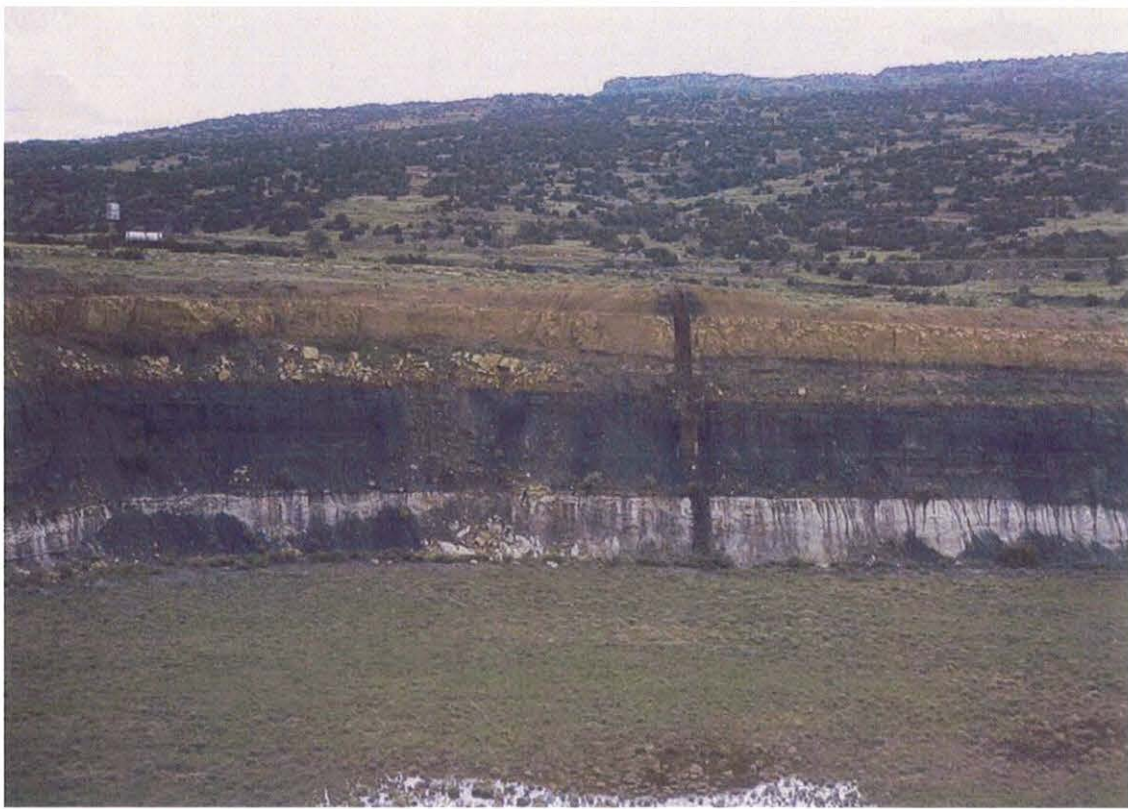
Work on the highwalls started with the highwalls of the South Paguate Pit. There were objections to the blasting from the Paguate Village. Project Status Report No. 9, April 1990, references a Seismic Study and Project Status Report No. 11, June 1990, a Blast Study documenting damage to many of the buildings in the Village. Photos B-5, B-6, and B-7 in Appendix B, show present day conditions of several of the highwalls.

Photo B-5: SP-OP-34 SW Highwall, Naturally Sloughing

Recommendations - A field assessment of the highwalls and Old Highway 279 should be made periodically to make sure that the highwalls do not comprise a threat to normal Pueblo of Laguna activities, or if additional fencing or other corrective measures are required during the erosion process. If significant hazard potential is present, other means of slope reduction should be evaluated, such as ripping, or alternatively, localized berming or other protective measures may be warranted. The south-facing wall at the North Paguate pit also needs to be periodically assessed to assure that it is eroding sufficiently to cover the exposed Jackpile Sandstone, as planned.

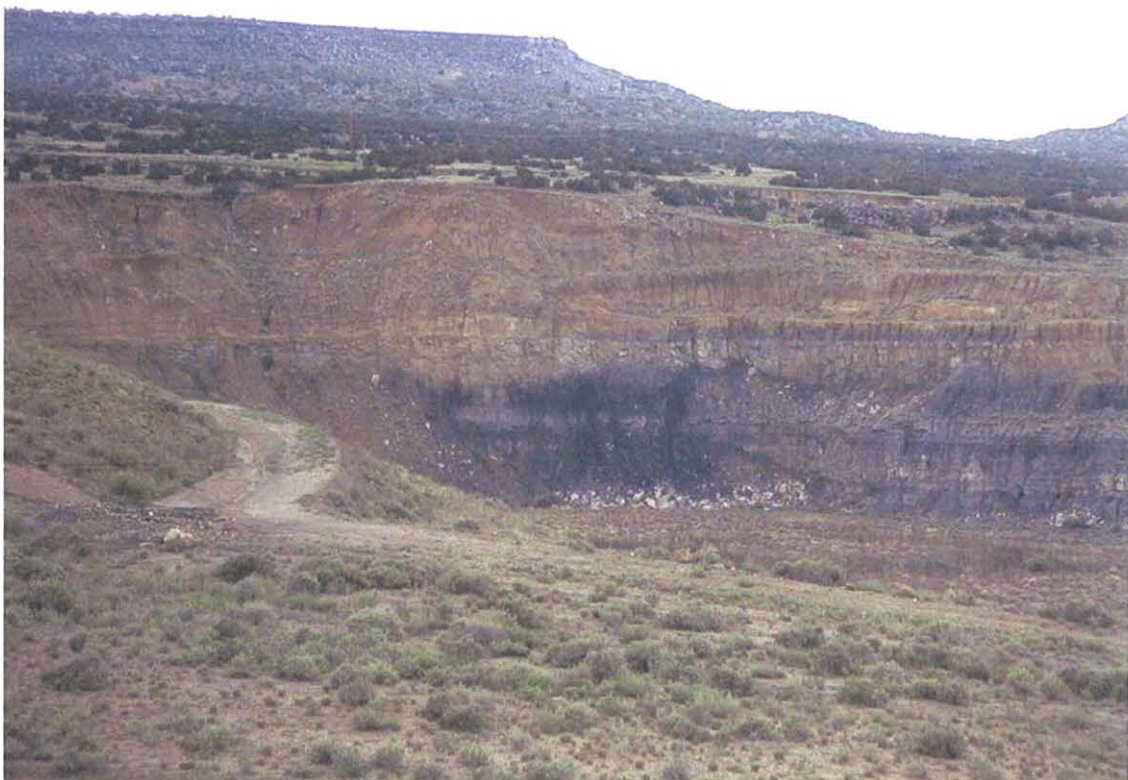
Photo B-6: SP-OP-35 Highwall

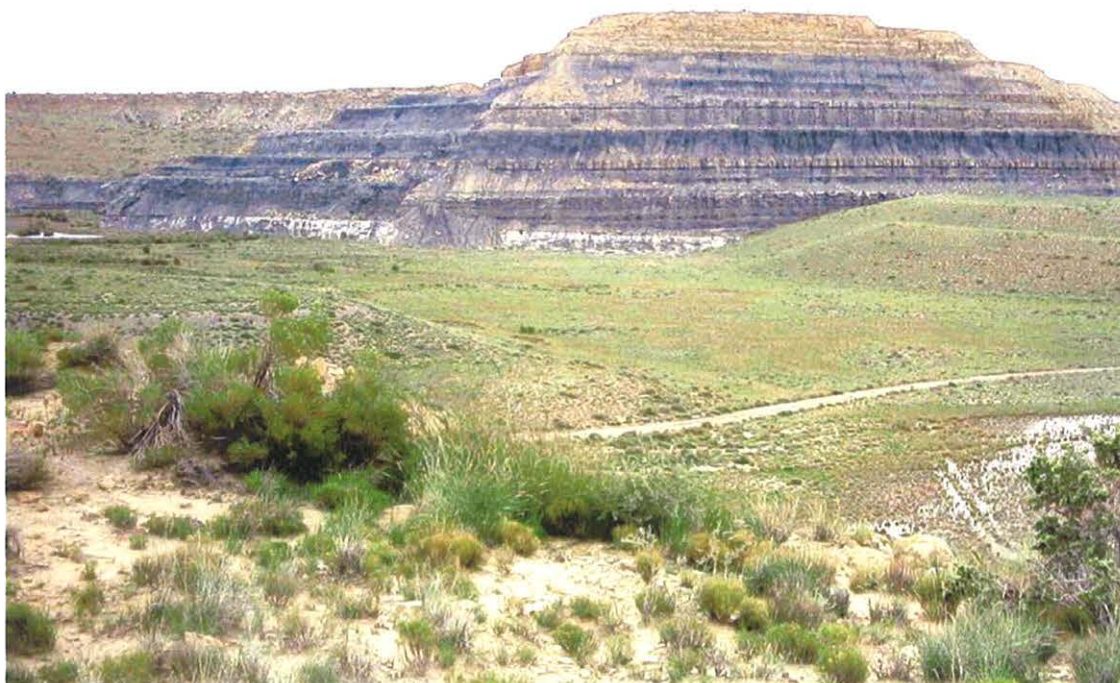
Photo B-7: Jackpile Highwall along Gavilan Mesa

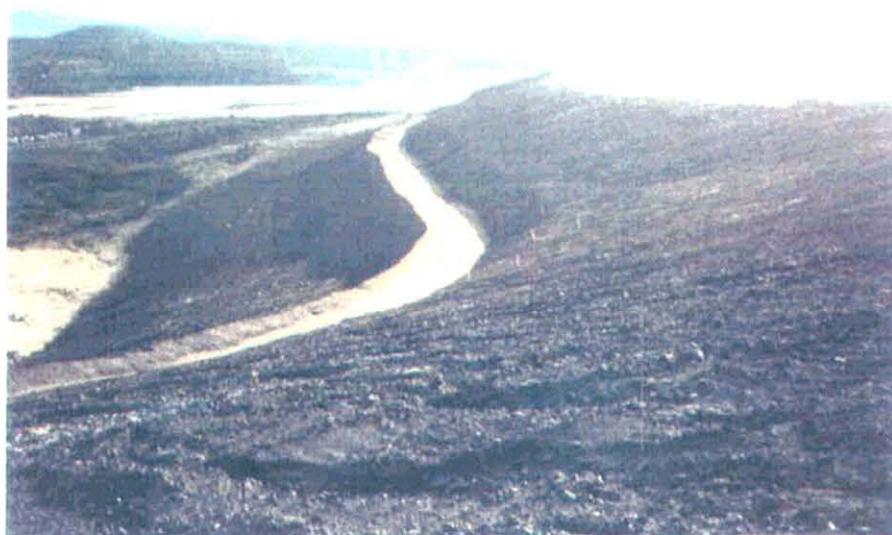
Photo B-8: Photo from Monthly Report No. 14 Figure 6 Terrace and Berm after unusually large rainfall

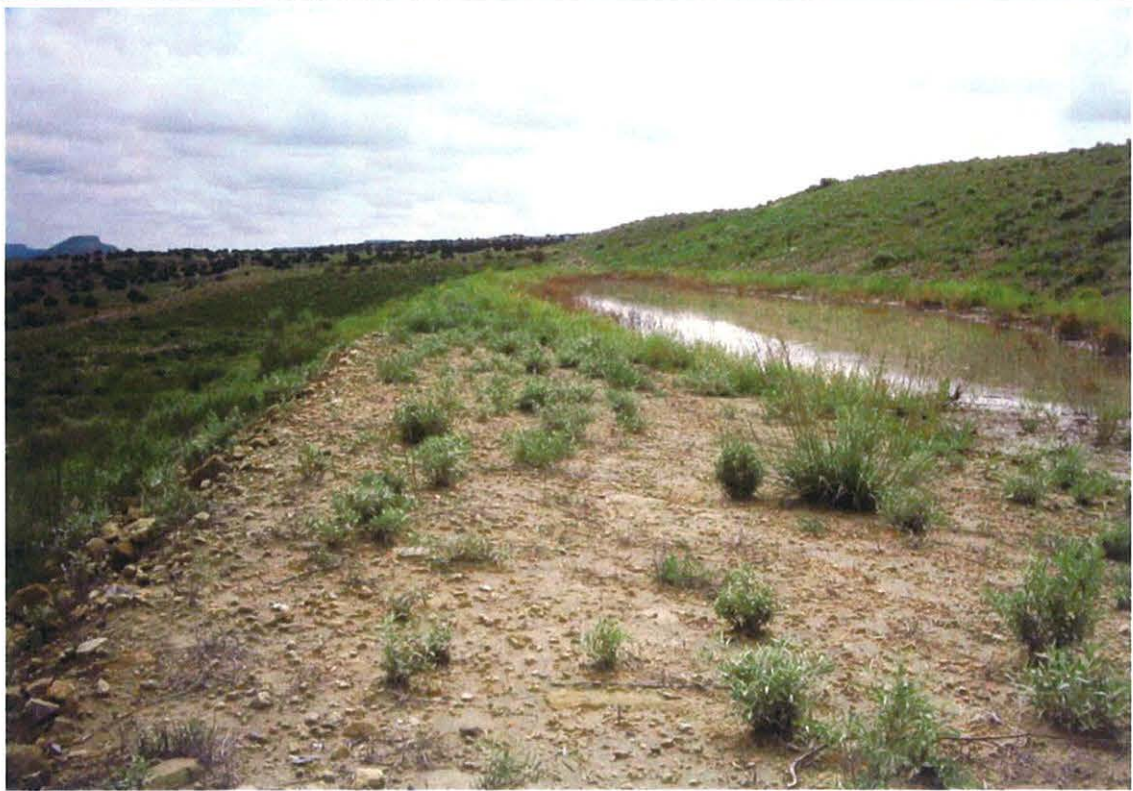
Photo B-9: Berm in South Paguate Pit, holding water as designed OAS Photo August 2006

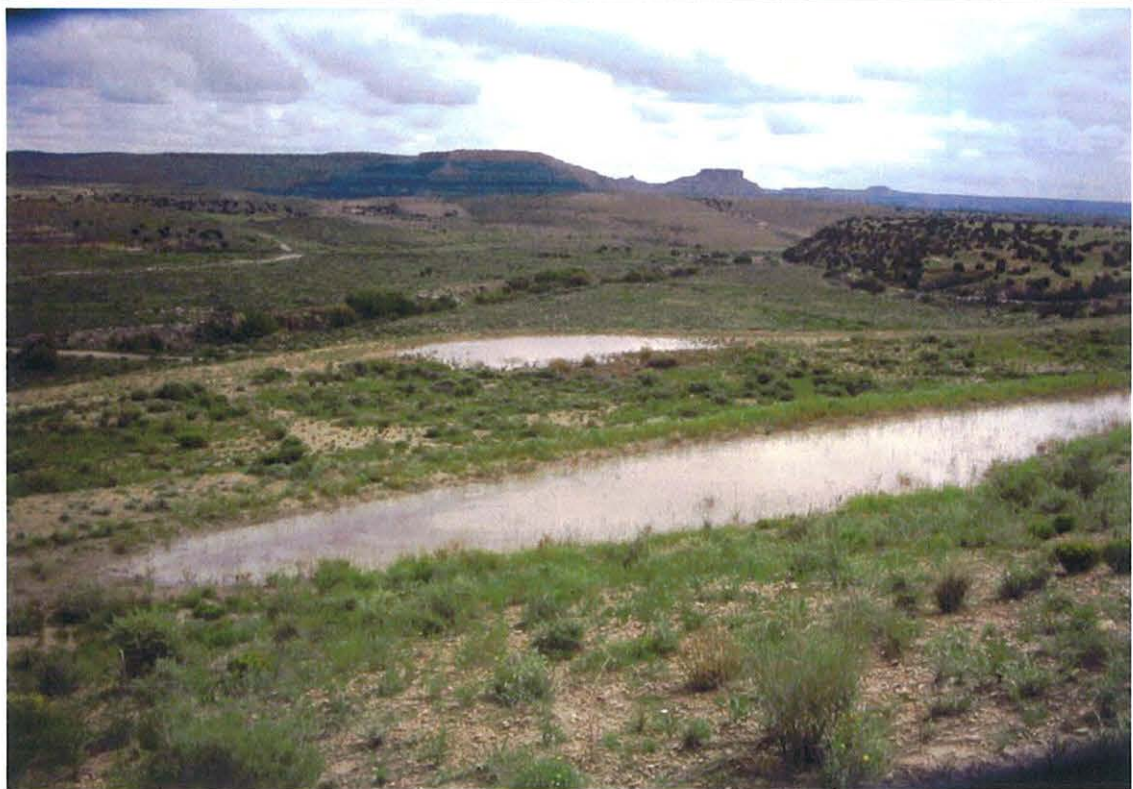
Photo B-10: Additional view of Berms in South Paguate Pit OAS Photo August 2006

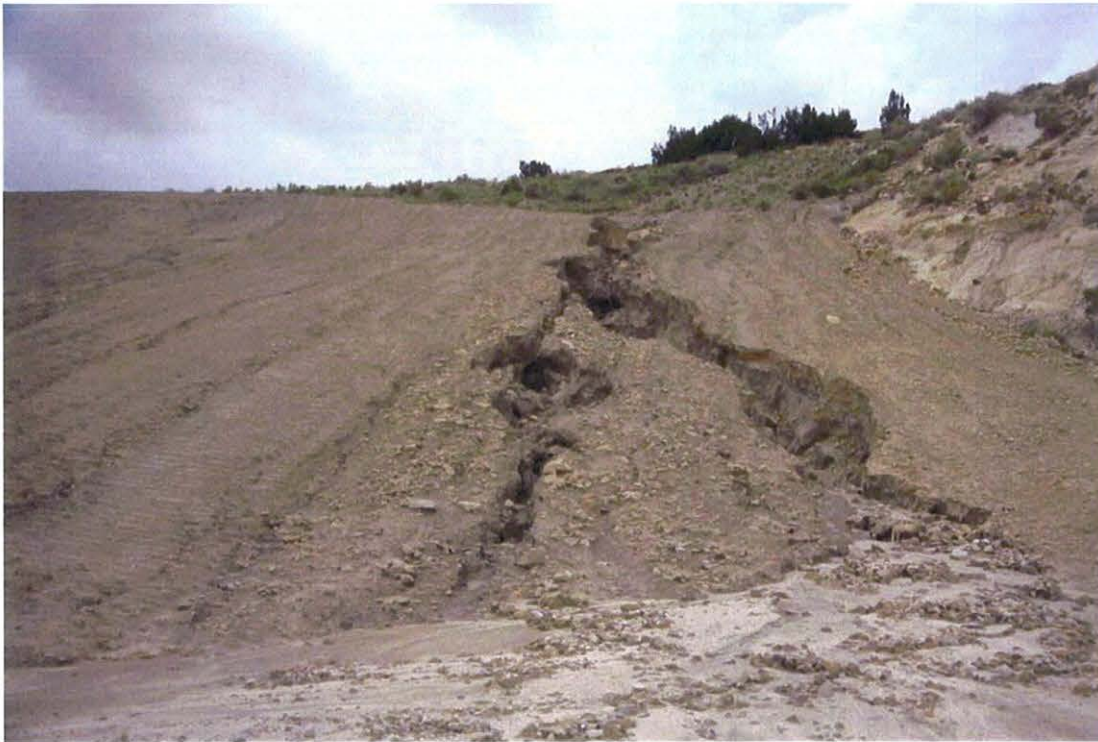
Discussion - The berms and contouring are working well except in limited cases where the excessive berm length causes too large a buildup of water resulting in predictable, chronic blow-out areas. Photos B-11 and B-12, Appendix B, show areas of chronic blowouts, due to water build up on long berm runs. The locations presented in Table 5 have been observed by M. Sarracino and Laguna Construction Company (LCC), to have chronic erosion problems. Maps indicating these areas are presented in Appendix C (Exhibits 1 and 2).

Photo B-11: South End of "I" above Road

Recommendations - An evaluation of the chronic blowout areas, to determine if solutions can be designed to relieve these continuing maintenance problems, is recommended. Erosion should be monitored with appropriate equipment to determine if radiological safety is a concern. If the underlying material is non-RAD emitting, the slopes may be allowed to erode naturally.

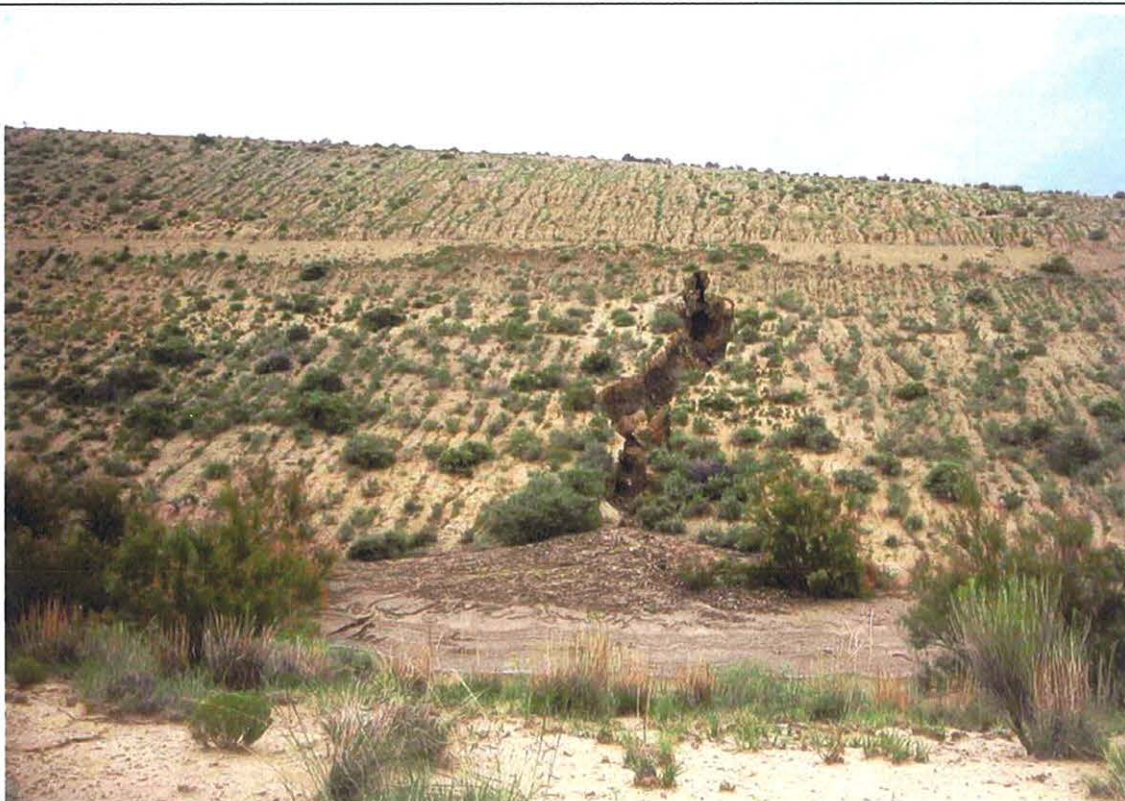
Photo B-12: Blowout in Pile "A" Lower Terrace

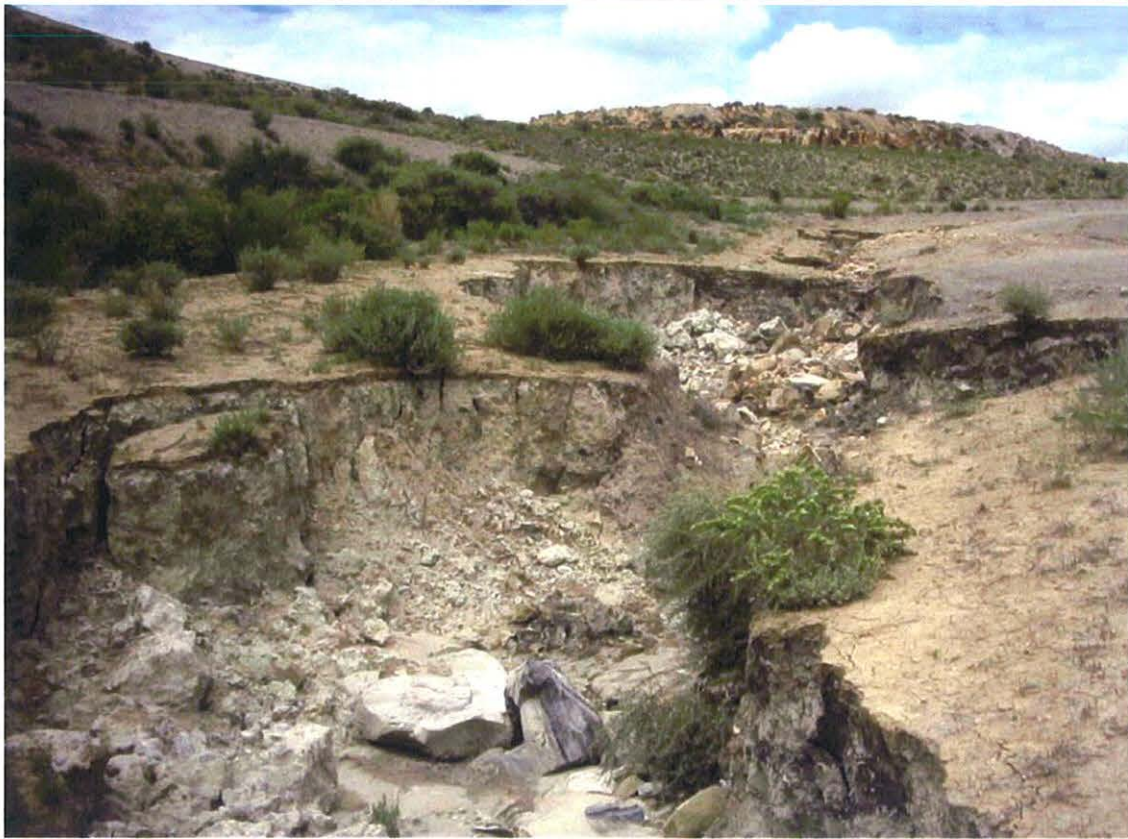
Photo B-13: Roadway Erosion East Side of Wastepile "I"

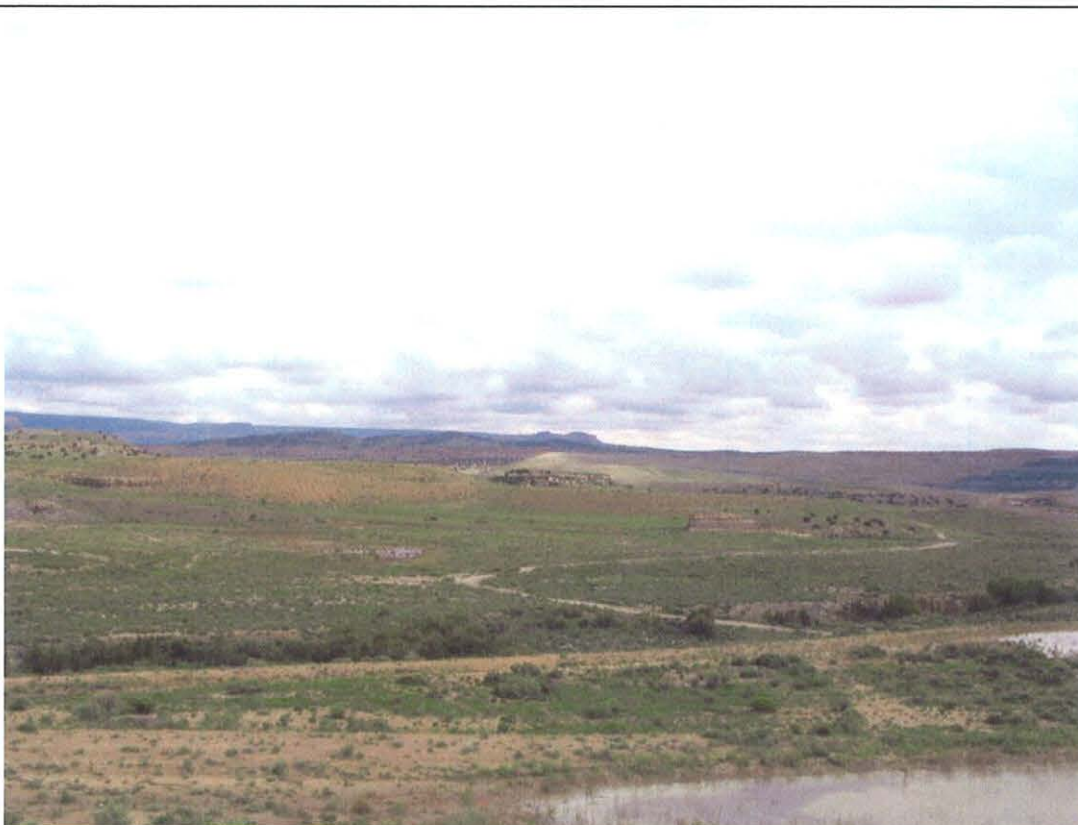
Photo B14: Location of former protore piles along the Rio Paguate OAS Photo August 2006

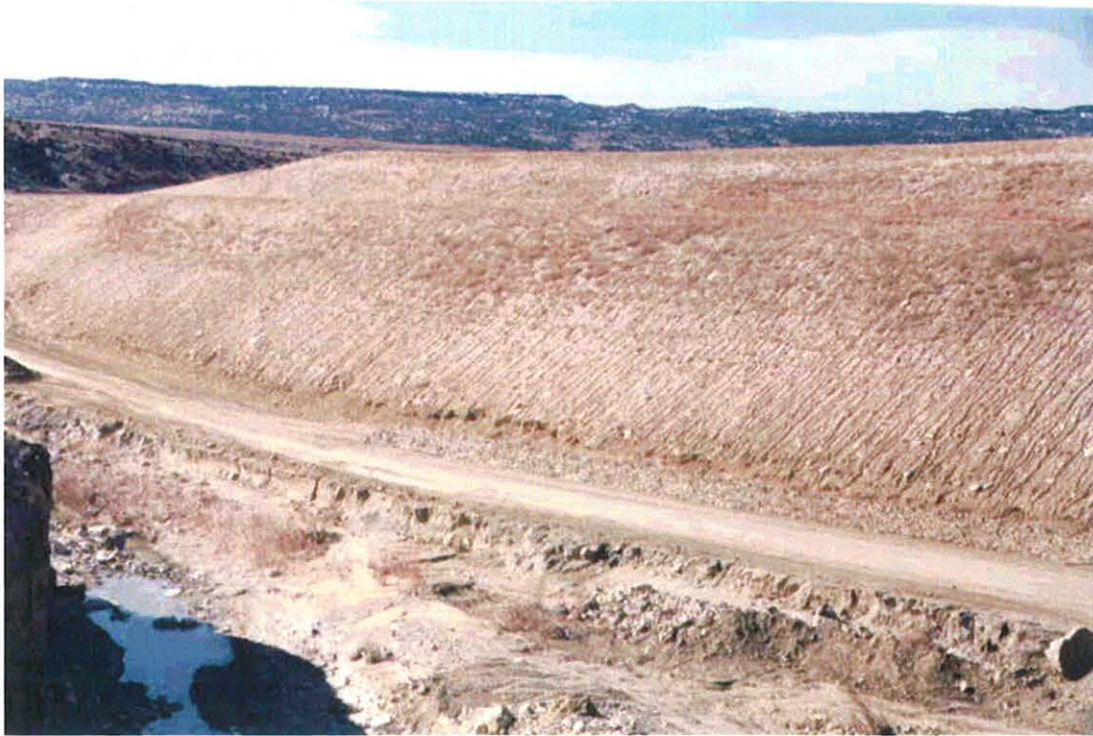
Photo B-15: Armored Toe of Pile "T" along the Rio Moquino. POL Archived Photo taken sometime after Armoring was completed (late 1994).

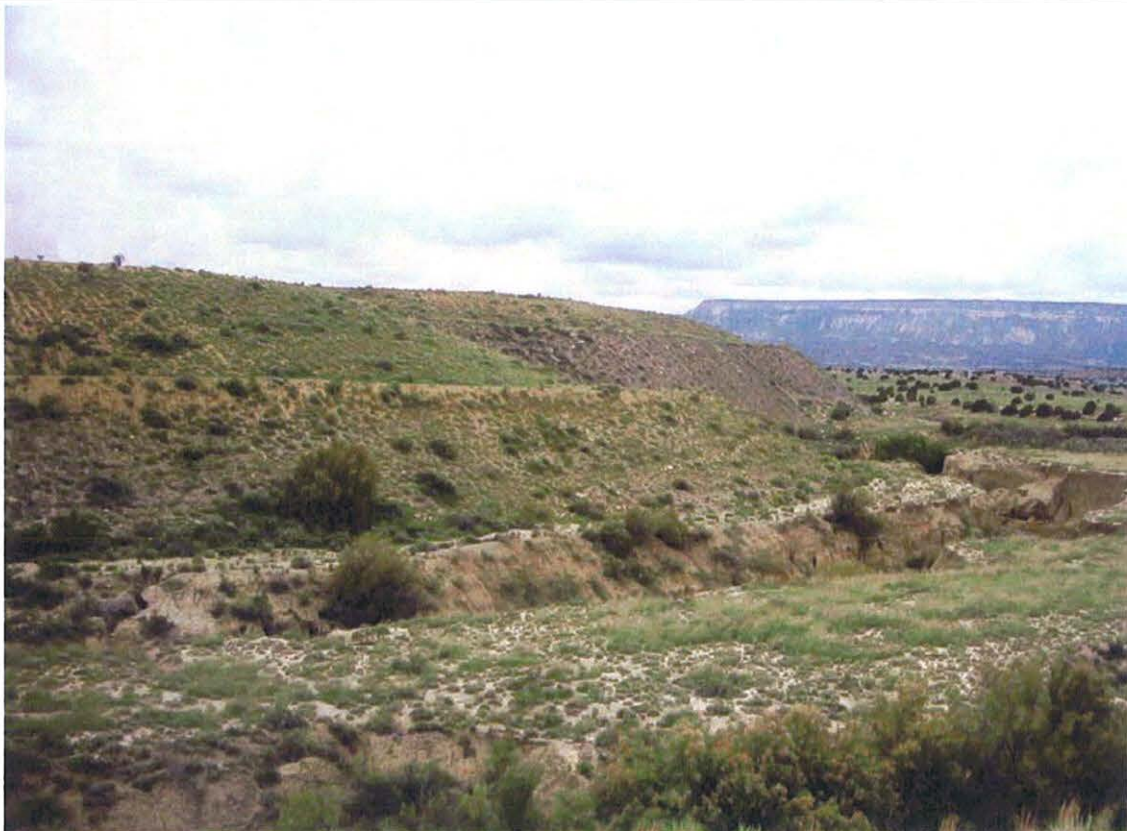
However, significant erosion has taken place in the past 12 years. If erosion continues at the same rate, there is serious potential for exposure of waste or contaminated soil at the toes of Piles S, T, U, N, and N2. In view of the fact that a less rigorous redesign was approved after the ROD, this unexpected erosion is a problem. If the erosion continues, waste material will be exposed creating the potential risk of human and wildlife exposure to unknown hazards, and a threat to the water quality of the Rio Moquino.

Photo B-16: Armored Toe of Pile "T" along the Rio Moquino, the former road area is almost completely eroded.
OAS Photo August 2007

Recommendations - A more thorough inspection and hydraulic analysis and erosion study needs to be performed to determine if additional erosion protection is needed along the Rio Moquino above the confluence. A control structure on the Rio Moquino above the Pueblo of Laguna section may also be considered.

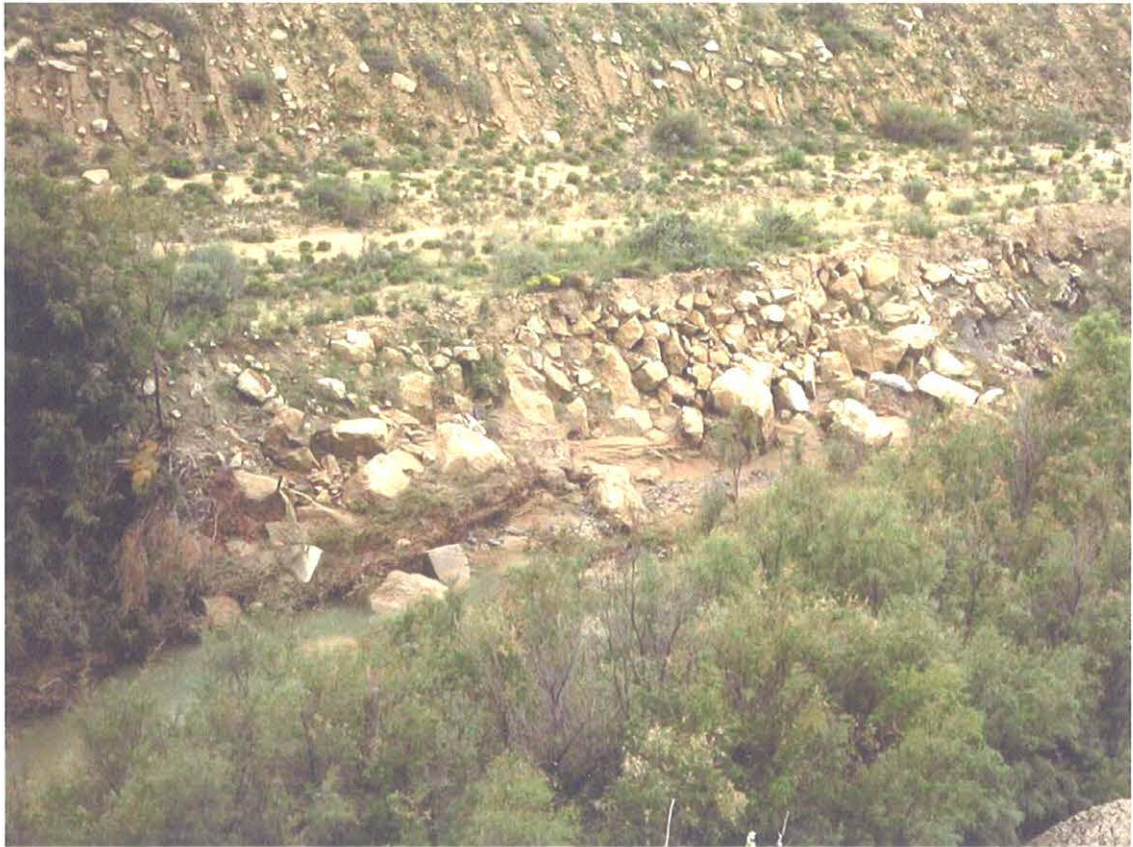
Photo B-17: Rip Rapped Toe of Pile “N” and “N2” along the Rio Moquino, Close up of Erosion of most of the former roadway.

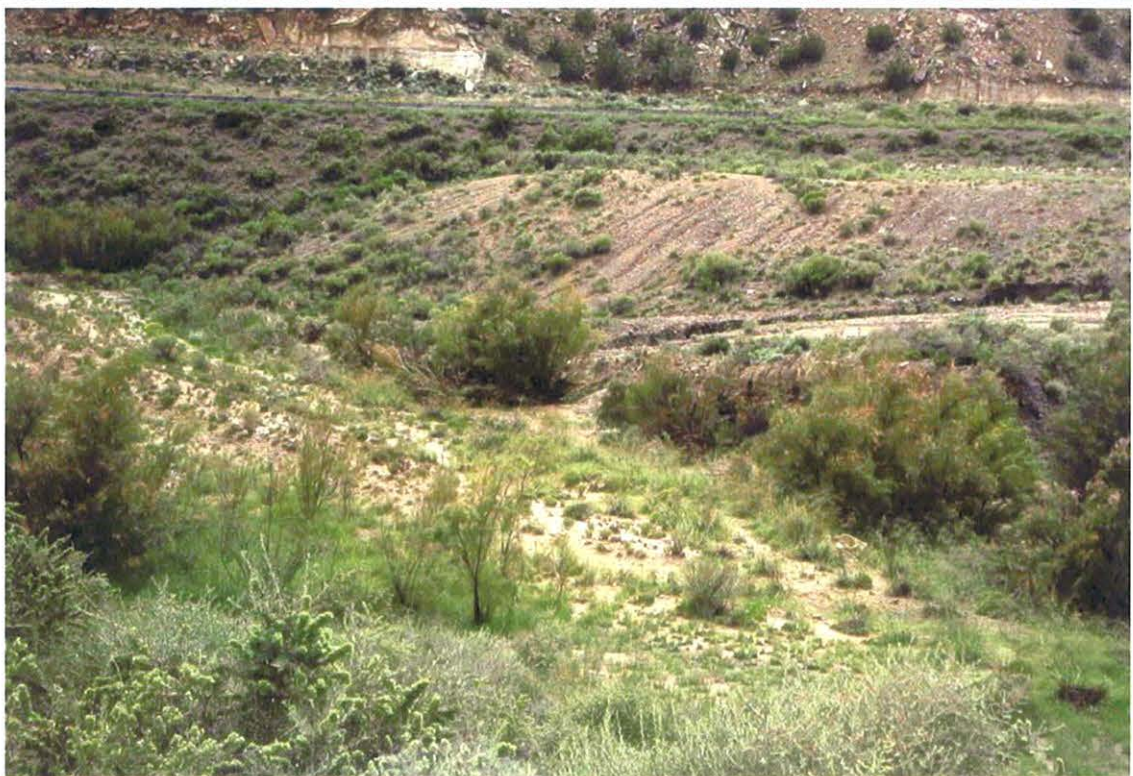
Conclusions - Due to the flash flood event that caused the stream crossing to be relocated and changed the stream flow conditions, the Rio Moquino drop structure was no longer needed. Therefore, compliance with this ROD requirement is not applicable.

Photo B-18: Former road crossing of Rio Moquino

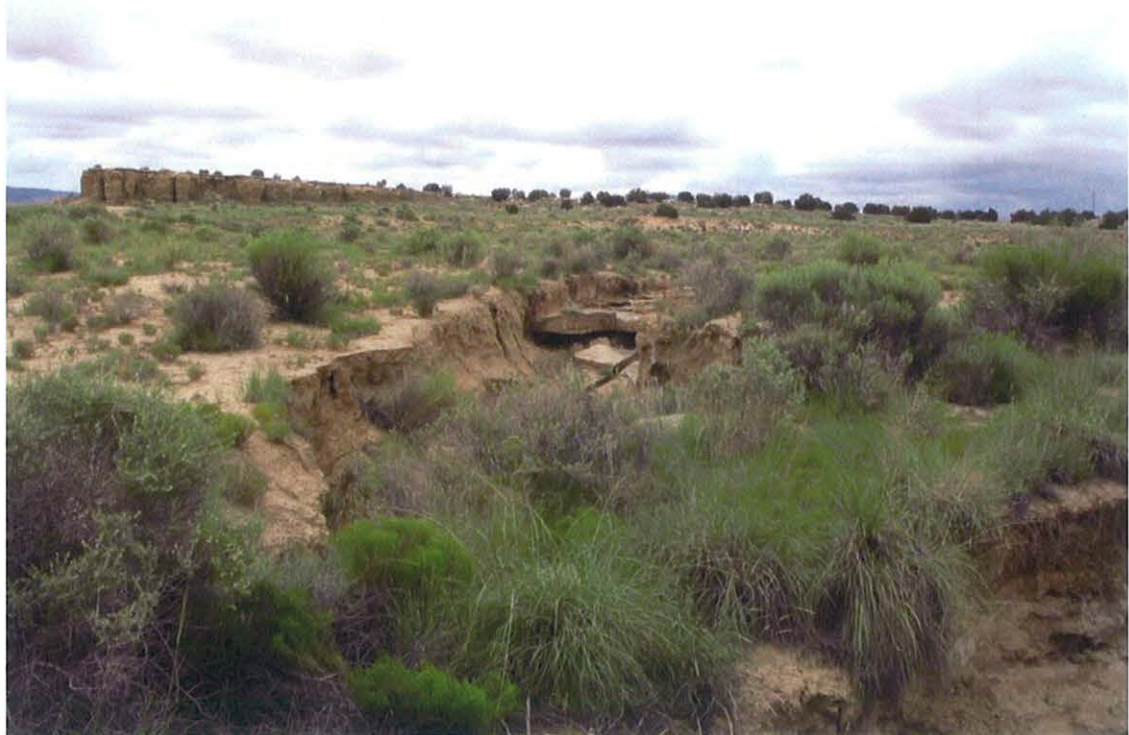
Conclusions - Based on OAS field inspection documented in the photograph, field conditions changed when the headcutting encountered a natural outcropping of sandstone. The sandstone impedes further headcutting negating the need for armoring. Therefore, this is considered a non-substantive variance from the ROD requirements.

Photo B-19: End of Headcutting , Area of Exposed Sandstone OAS Photo August 2006

Recommendations – No further activities are recommended at this time.

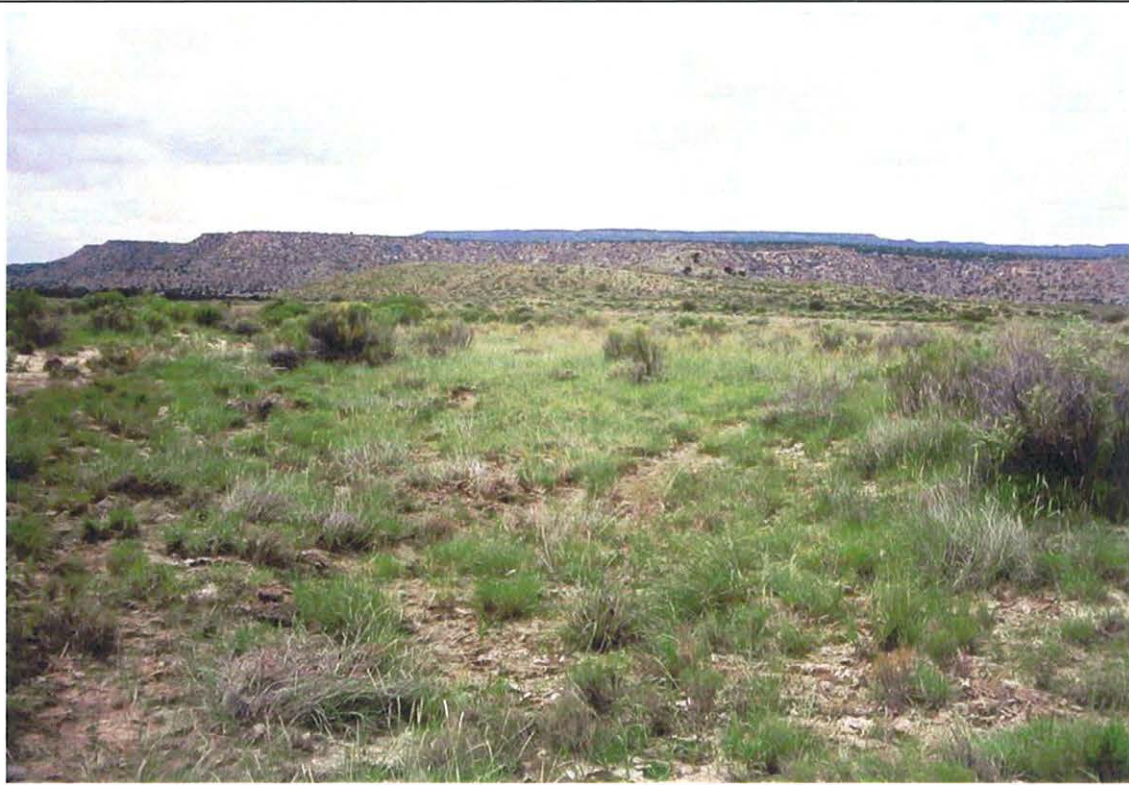
Photo B-20: In the background is Waste Pile "J" which was left in place, the area in front is the east side of "J" and contained the former protore piles "SP-6B and SP-17B C". OAS Photo August 2006

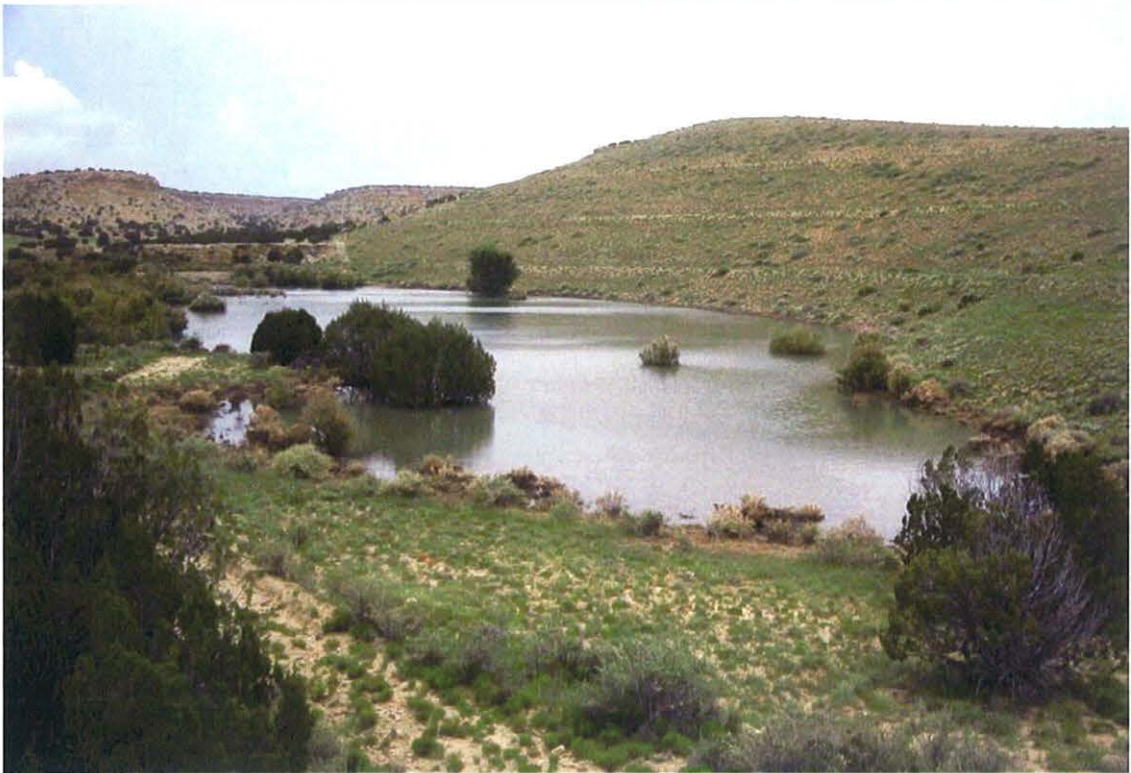
Photo B-21: Blocked Drainage North of FD-1

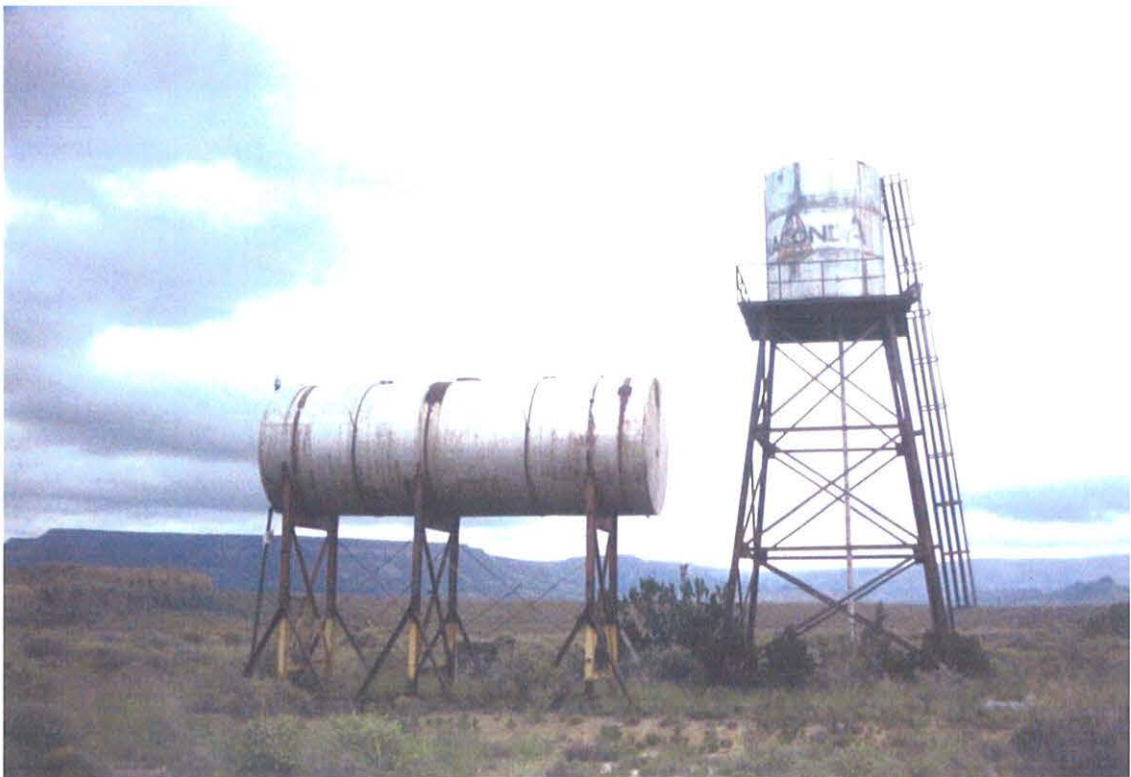
Photo B-22: P-10 Well and Tank.

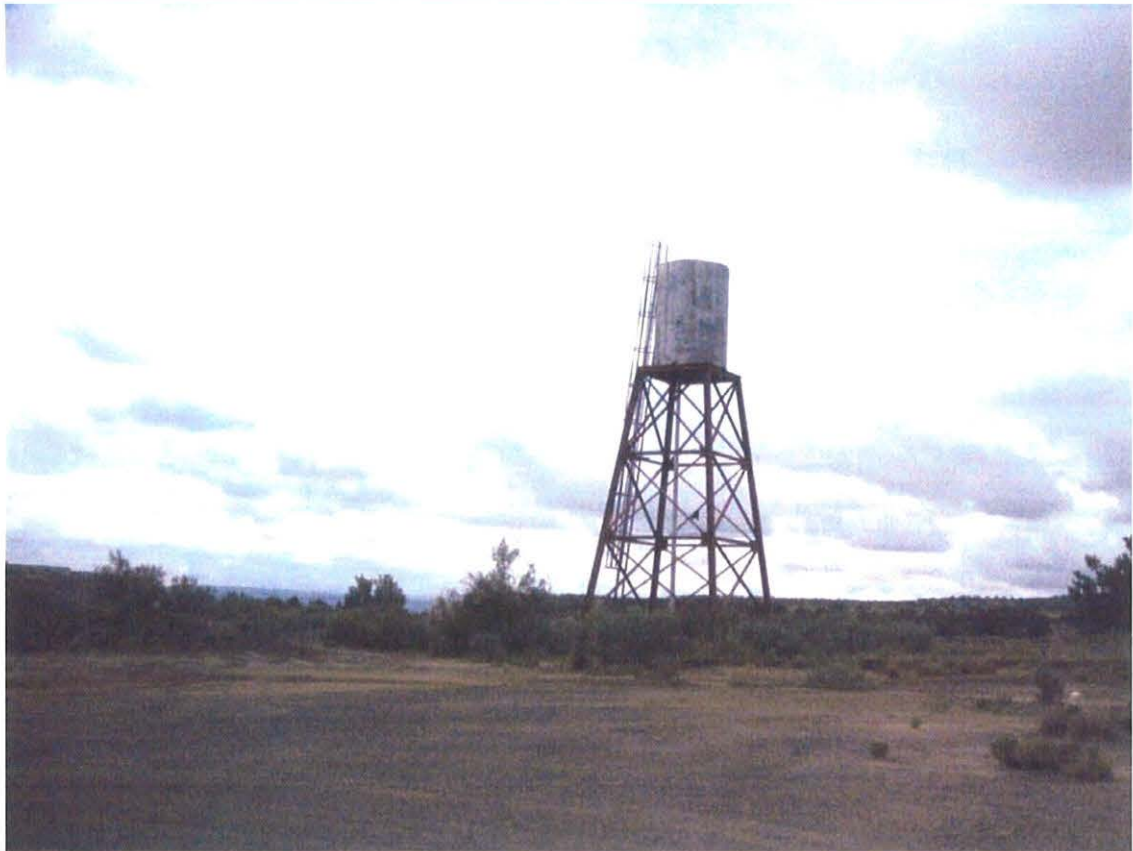
Photo B-23: New Shop Well and Tank.
